May 20, 2004

**RE: Bathymetric Survey and Plan
Tabb Lakes Homes Association
WEG Project #1256A**

Reference: Report of Subsurface Exploration
Tabb Lakes Dredging Investigation
York County, Virginia

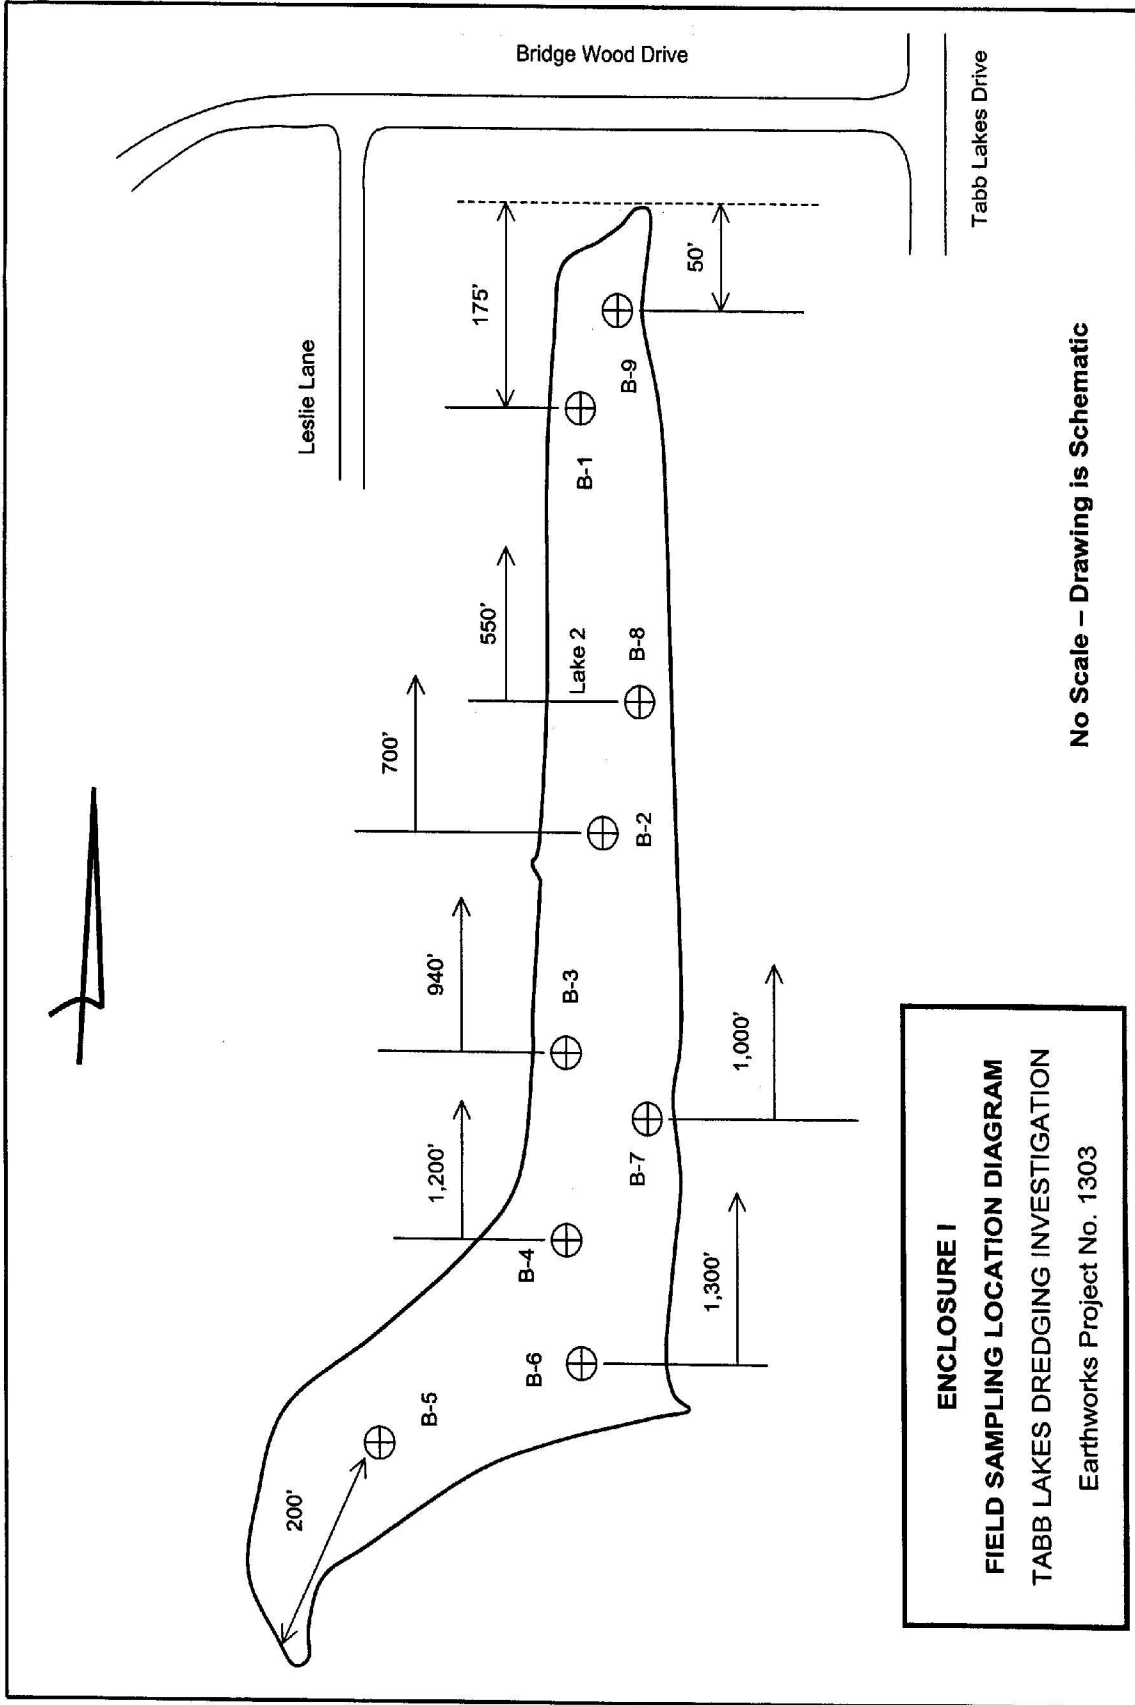
ENCLOSURE I
FIELD SAMPLING LOCATION DIAGRAM
TABB LAKES DREDGING INVESTIGATION
 Earthworks Project No. 1303

Based on the results of our field sampling, it appears that lake depths observed by Earthworks are generally consistent with those shown on the project drawings, except that we encountered somewhat deeper water at the south end of the lake (see Enclosure II, B-5).

Soils underlying the sediment layer consisted primarily of gray, fine to medium SAND (SP and SM). Some of these Sands contained marine shell fragments, indicating they are probably from the original lake bottom and not accumulated sediment. While most soils encountered below the sediment were Sandy in nature, Clayey soils were encountered below a thin layer of sediment in the vicinity of B-3 and B-7. These were relatively shallow areas in the vicinity of what may have been a road crossing, now submerged, of the original Sand pit from which the lake was created. This area is midway between cross-sections K and J on the project drawings.

Furthermore, it appears that Clay soils which were encountered in the shallower waters in the vicinity of B-3 and B-7 would be resistant to hydraulic dredging, as they appear to consist of relatively stiff Clayey SAND (SC) and Sandy CLAY (CL). A dredging contractor may determine that this area requires mechanical excavation.
